# Manhole Inspection Summary

Manhole # S25EE1040MH

**Inspection** ☐ Is Incomplete Rating: **4) Poor**

**Location** Address: **1015 RECTORY LN**

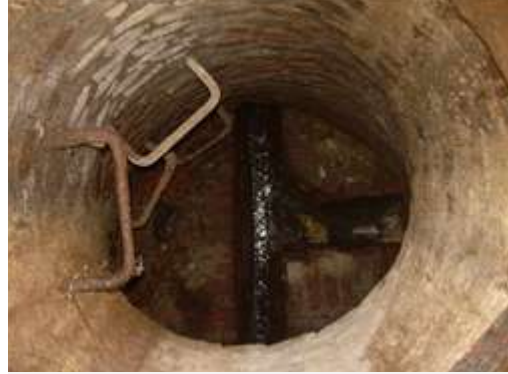
Top View

Corroded steps. Evidence of surcharge - Bench debris. Channel debris.

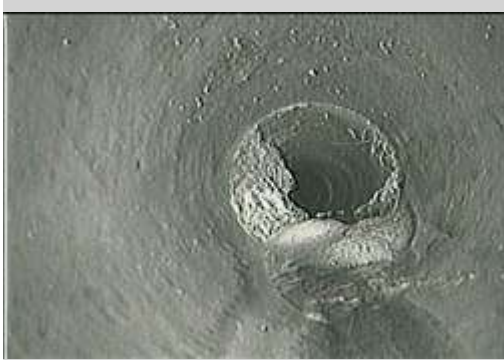
Inside the O12

Root intrusion.

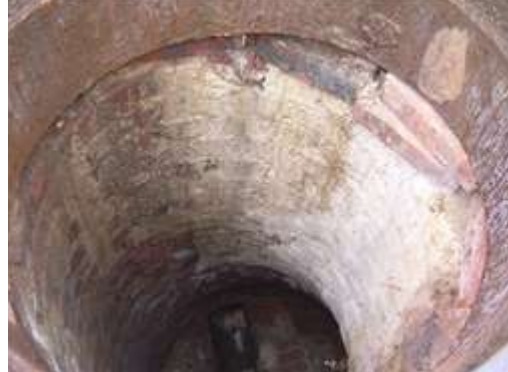
Defect

Frame leaks. Adjustment deterioration, loose brick and infiltration - other side.

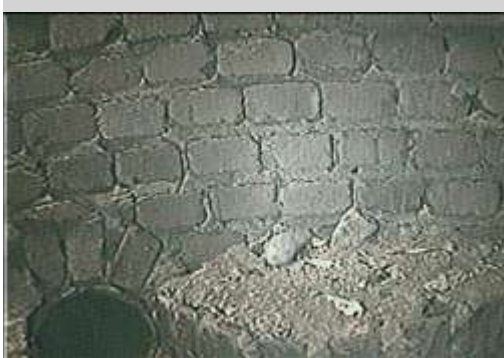
Defect

Barrel deterioration and infiltration.

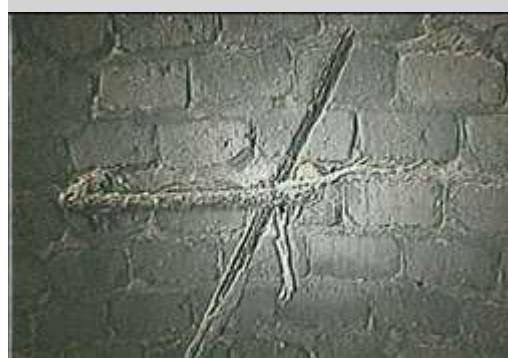
Defect

Evidence of surcharge.

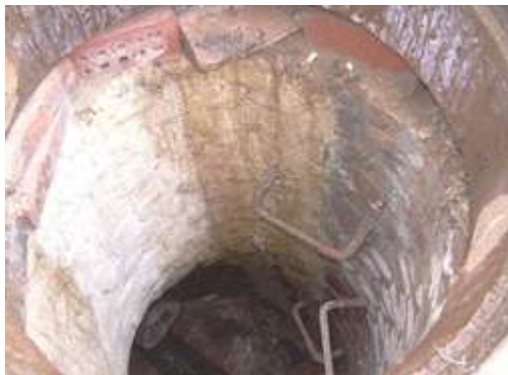
## Defect

Frame leaks. Adjustment deterioration, loose brick and infiltration.

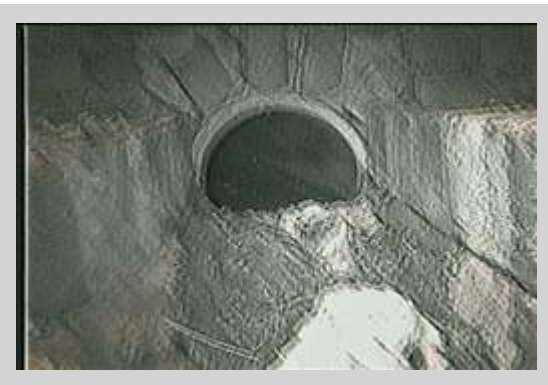
### 8 in. Circular Gravity Sewer Pipe In @ 3 O'Clock

Channel deterioration and debris.

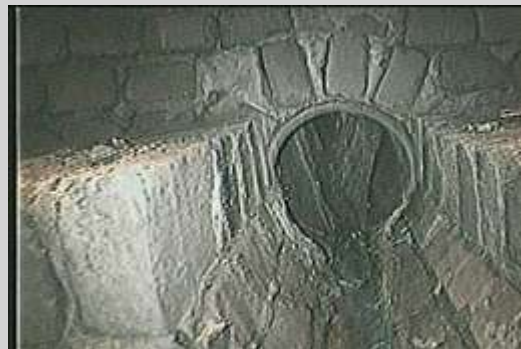
Drop In @ 6 O'Clock

Barrel deterioration and infiltration. Channel deterioration.
